# US HIGHWAY 26 WILDLIFE MITIGATION STRATEGY

September 2021

Wyoming Game and Fish Department

Wyoming Department of Transportation

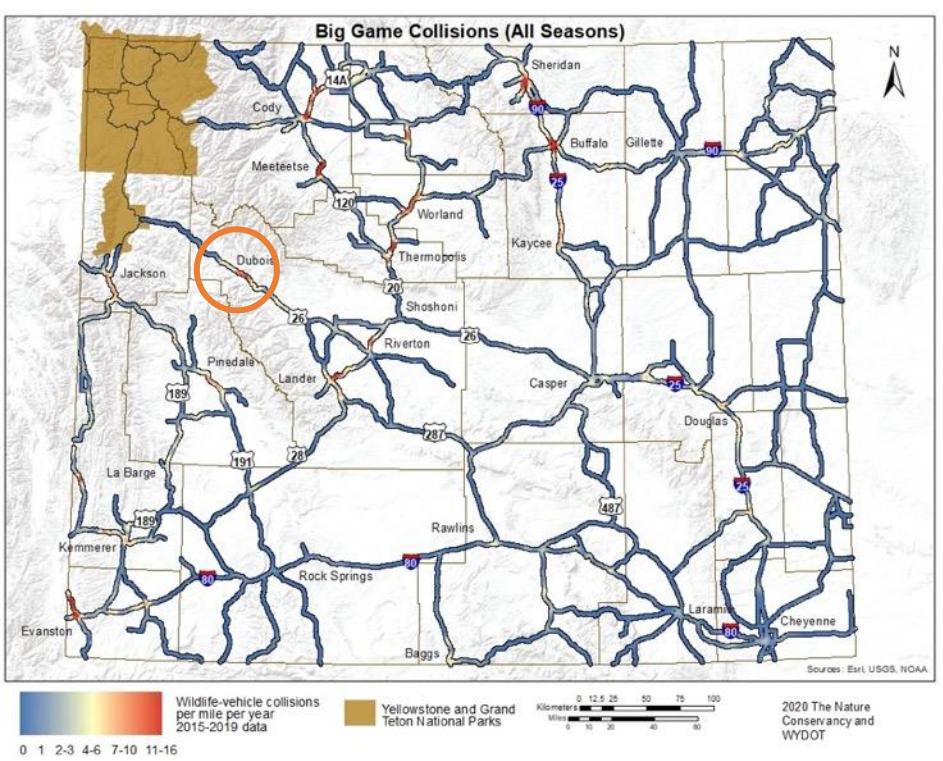
Figure 1. Heat map of wildlife-vehicle collision hotspots in Wyoming based on kernel density analysis (2015-2019 crash and carcass data). Orange circled area is the Dubois US 26 hotspot (map created by C. Riginos, The Nature Conservancy).

In April 2017, the WYDOT and WGFD jointly hosted the Wyoming's Wildlife and Roadways Summit, which convened state agencies, non-governmental organizations, members of the public, and other stakeholders to address the conflict that arises where migrating and wintering wildlife intersect with the state's road network. Following the Summit, the cooperating agencies formed the Wyoming Wildlife and Roadways Initiative Implementation Team and produced a <u>Road Map</u>. The Road Map summarizes the issues raised during the Summit and provides recommendations for improving collaborative partnerships to build capacity and implement more projects with the objective of reducing wildlife-vehicle collisions (WVC), increasing motorist safety, and maintaining or reestablishing wildlife migrations and habitat connectivity in Wyoming. Through a subsequent prioritization process, US 26/287 (hereafter US 26) around Dubois from Stoney Point to Dinwoody Creek (mileposts 48-73) emerged as one of the

top priorities in the state (Fig. 1).

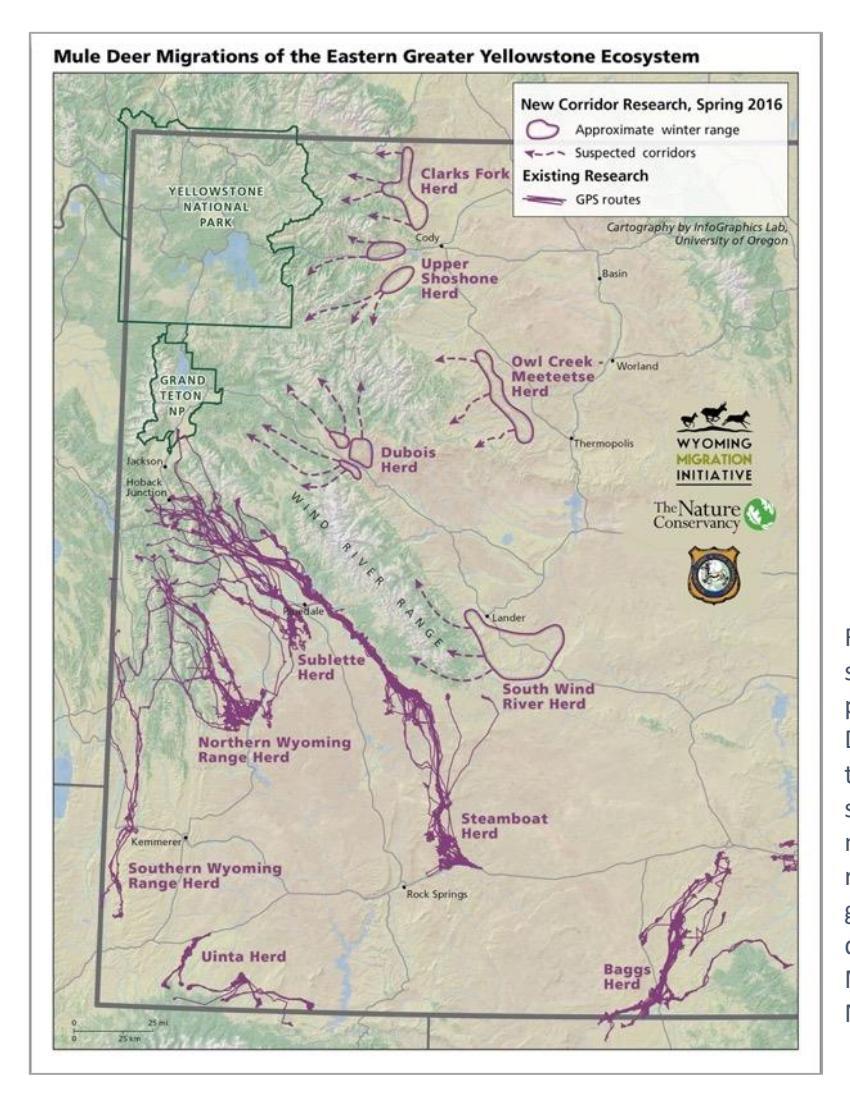
Figure 2. Map of established and suspected mule deer migration paths in western Wyoming. The Dubois herd is one of five herds that is part of a multi-year collaring study to better understand migration movements in this region. The map depicts the general migration paths of mule deer that winter around Dubois. Map courtesy of the Wyoming Migration Initiative.

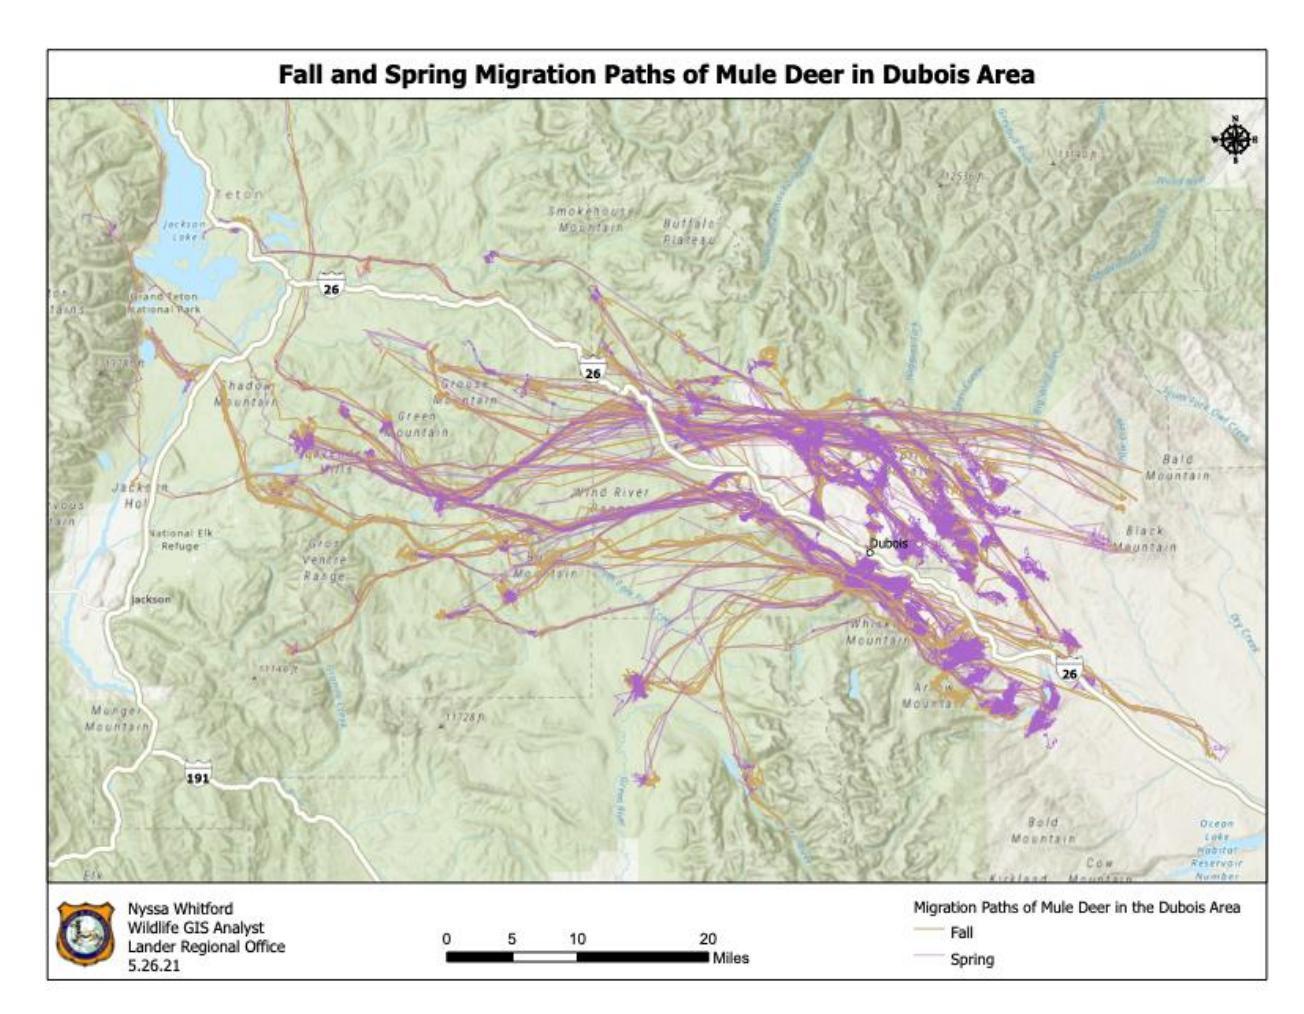
Figure 3. Fall and spring migration paths of mule deer wintering in the Dubois area, based on 63 deer collared by WMI/TNC/WGFD, WRR, and the National Park Service, 2016-2019.

Wind River valley generally migrate west to higher elevation summer ranges around Togwotee Pass and the southern Absaroka Mountains, in the Gros Ventre, or as far as Grand Teton National Park (Fig. 3).

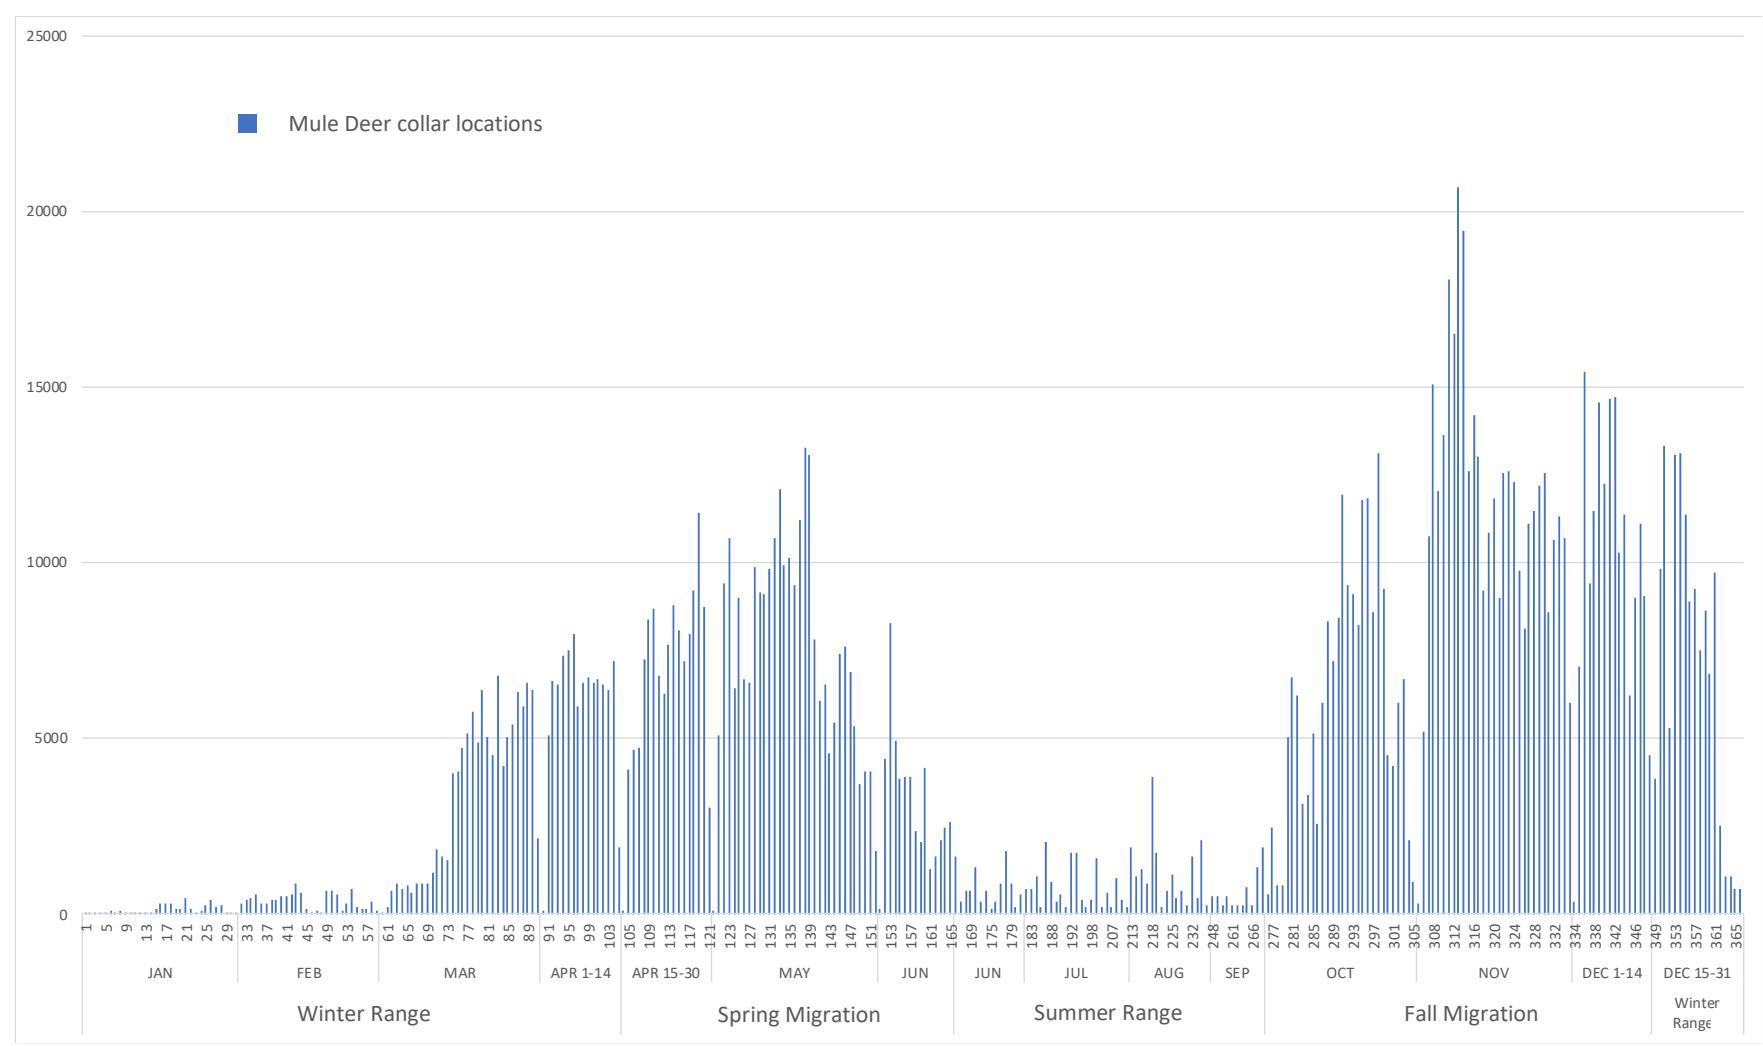
Figure 4. Mule deer collar points collected within one mile of either side of US 26 by day of the year.

Collar datasets confirm that the fall migration is more dispersed, spatially and temporally, and appeared to be more dependent on environmental conditions, while the timing of the spring migration was much more consistent from year to year (Anderson, 2021). Figure 4 displays the seasonal variation in mule deer activity within one mile of the highway by date, based on the locations of 57 collared animals from 2016-2019 (based on data from WMI/TNC/WGFD and WRR). From left to right, this graph demonstrates that mule deer activity around US 26 is lowest during the mid-winter months of January and February; beginning in March, through early June, mule deer activity adjacent to the highway increases through the spring migration; near-highway activity decreases again during the summer months; and in October, activity levels increase again concurrent with the fall migration, with a peak in November. These seasonal fluctuations in near-highway activity are reflected in the WVC data.

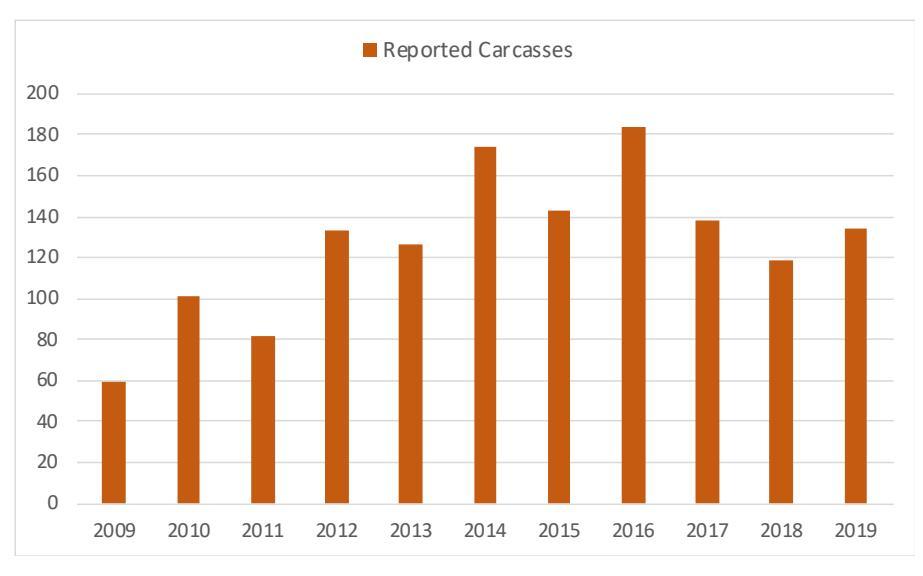
Figure 5. Total reported WVC carcasses per year for MP 24-73.

From 2015-2019, a total of 187 WVC crashes were reported to law enforcement in the study area from MP 24-73. Deer were involved in 91% of these accidents; other species involved in WVC crashes included elk, pronghorn, and moose. Carcass reports document 714 WVCs during this timeframe and describe a similar pattern: 90% of carcass pickups were mule deer; 7% white-tailed deer; and the remainder were elk, pronghorn, moose, or bighorn sheep. WVC carcass reports have generally increased over time in the study segment (MP 24-73) from 59 WVCs in 2009 to 134 in 2019, with some annual variation (Fig. 5). The highest number of carcasses were reported in 2016 (184) and 2014 (174). While some of this increase may be due to increased reporting effort over that timeframe, these trends match the increase in WVCs observed statewide.

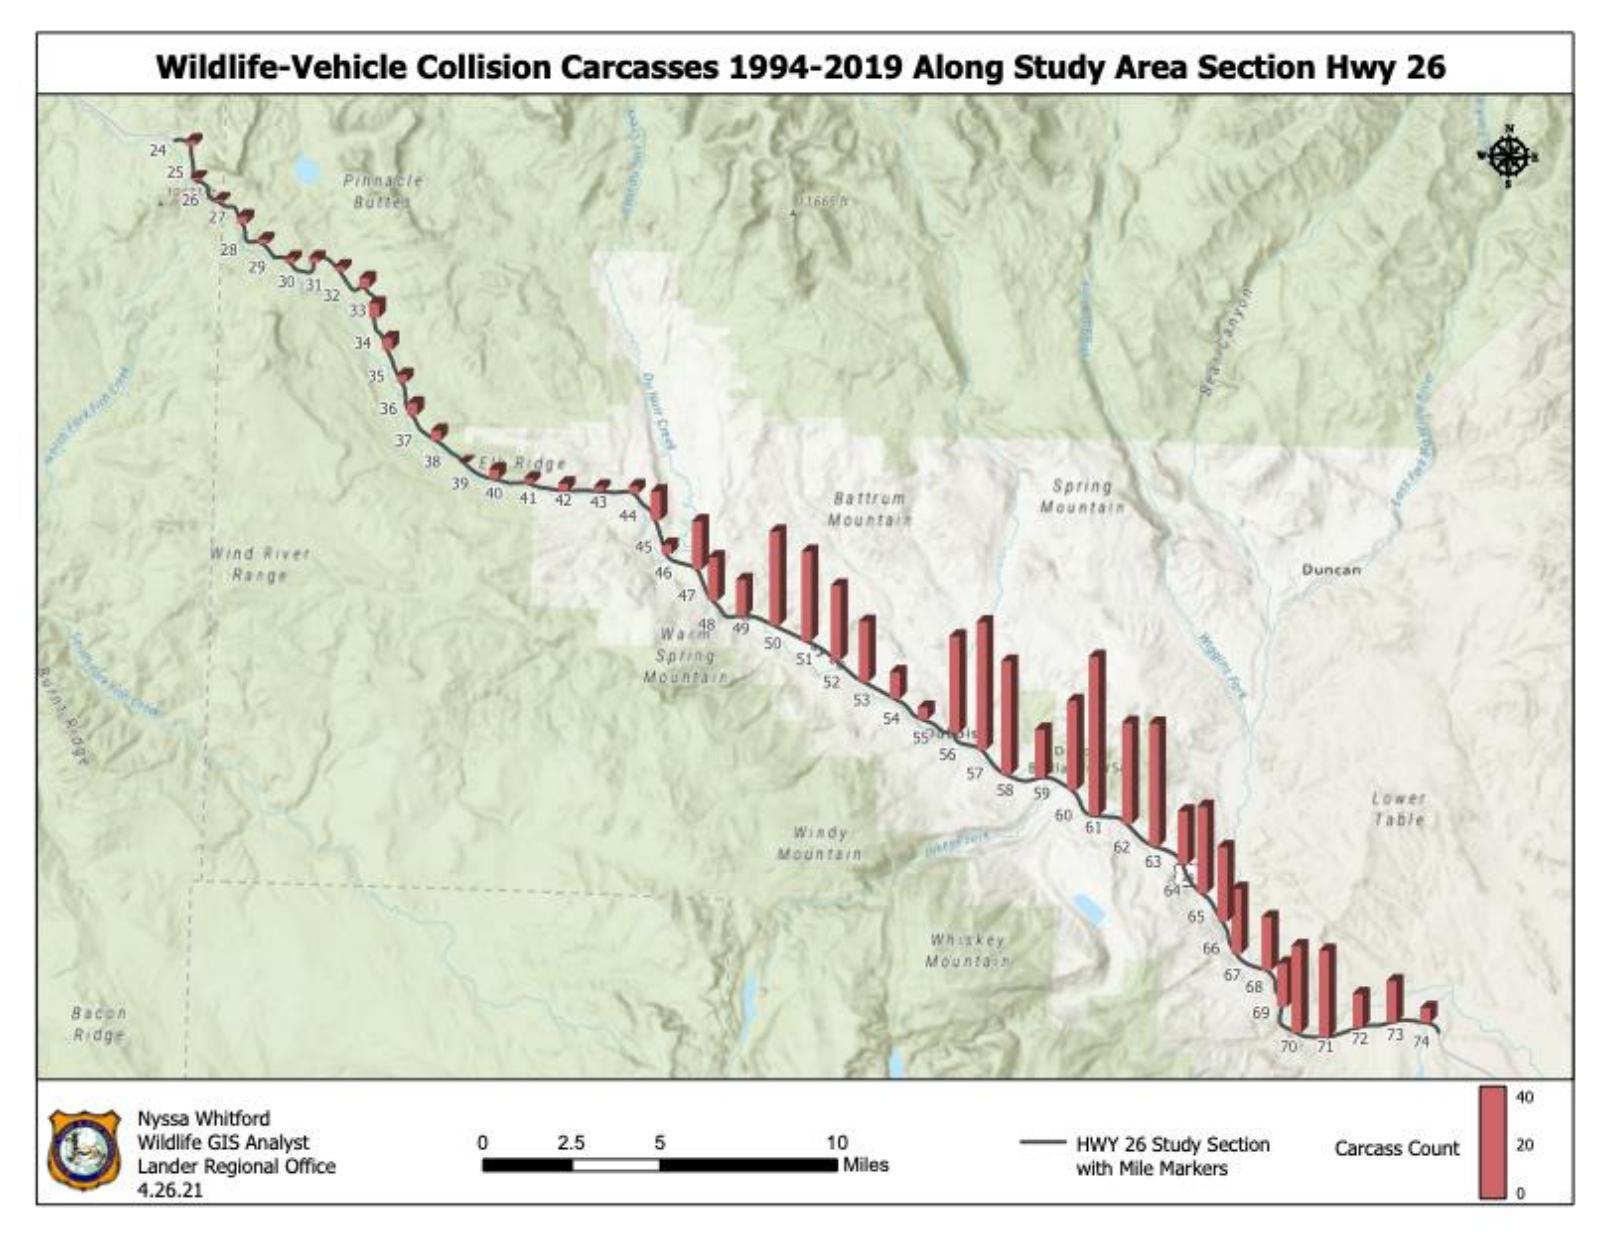
Figure 6. WVC crashes and carcass reports by milepost (2015-2019). Dubois is between MP 54-56; Stony Point is at MP 49; and summit of Togwotee Pass is around MP 26.

WVCs occur throughout the study area, but the highest frequencies of WVCs are in the eastern portion of the study area: from 2015-2019, 88% of all WVCs occurred between MP 48-72 (Fig 6). While collisions involving mule deer occur throughout the study area, collisions with other species are more localized. White-tailed deer WVCs are concentrated on either side of Dubois, from MP 51-53 and MP 58-69. WVCs involving elk occur primarily in the western half of the study area, with a small spike at MP 58.

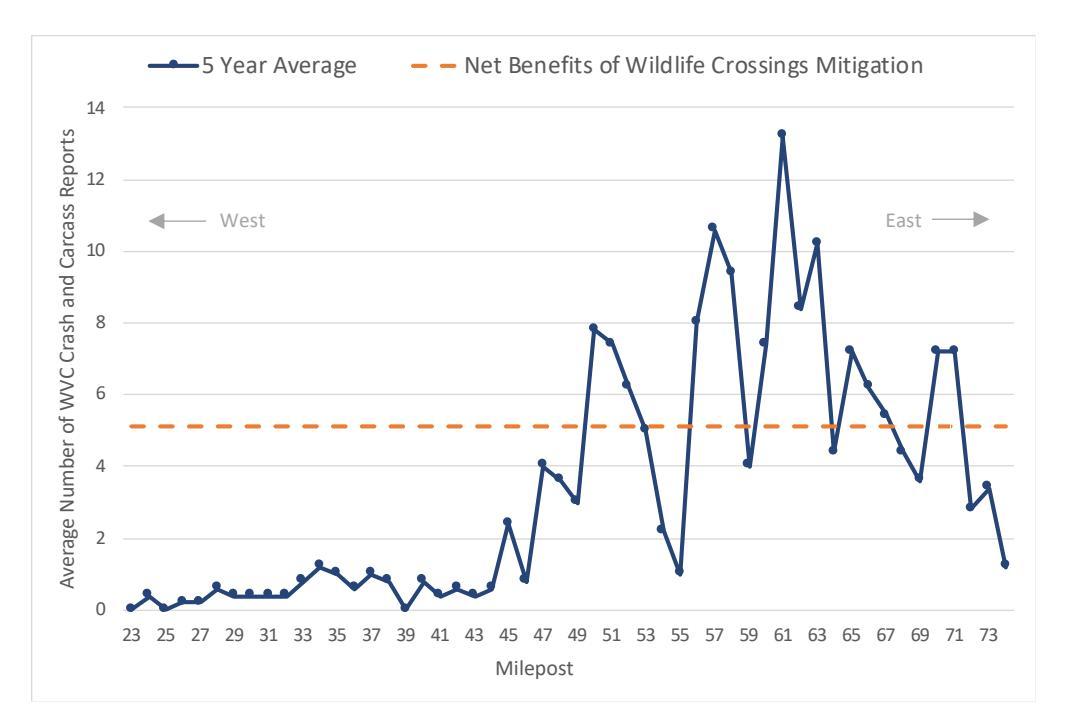
Figure 7. Annual average number of WVC crash and carcass reports per milepost, based on five years of data (2015-2019). At 5.1 WVCs per mile per year (orange line), the annual savings from reduced collisions equals the annualized cost of constructing and maintaining wildlife crossings.

In the eastern portion of the study area (MP 48-72) there were, on average, 6.1 combined WVC crashes and carcasses recorded per mile per year. As traffic volumes increase, the number of WVCs is also expected to increase (Riginos et al. 2016). Huijser et al. (2009) note that wildlife crossings mitigation can create net public benefits in terms of cost savings to society along road segments with 5.1 WVCs per mile per year. In the US 26 study area, multiple one-mile segments exceed this threshold (Fig. 7). Overall, fewer WVCs occur within the Dubois town limits, where traffic speeds are lower, and in the western portion of the study area, where mule deer are dispersed in summer range or where they cross US 26 only twice per year, during spring and fall migrations.

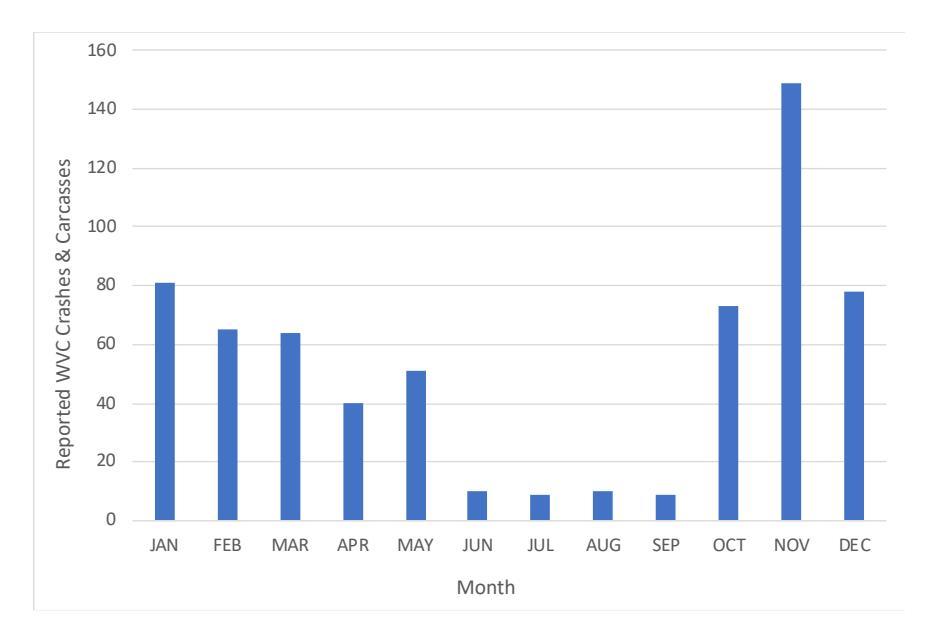
Figure 8. Total number of WVCs in the study area involving mule deer by month of the year from 2015 through 2019.

Most WVCs involving mule deer occur during the fall and early winter (Fig 8). From 2015-2019, across the study area, WVCs are highest from October through March, with a large spike in November, corresponding with the arrival of migratory mule deer on winter range and rutting season, during which both buck and doe movements into the highway are less predictable. WVCs are lowest during the summer months, reflecting the lower concentration of resident animals present year-round. In the higher elevation western portion of the study area, around Togwotee Pass, collisions with mule deer are restricted to the late spring through early fall (May – October), when deer are migrating or present on summer range.

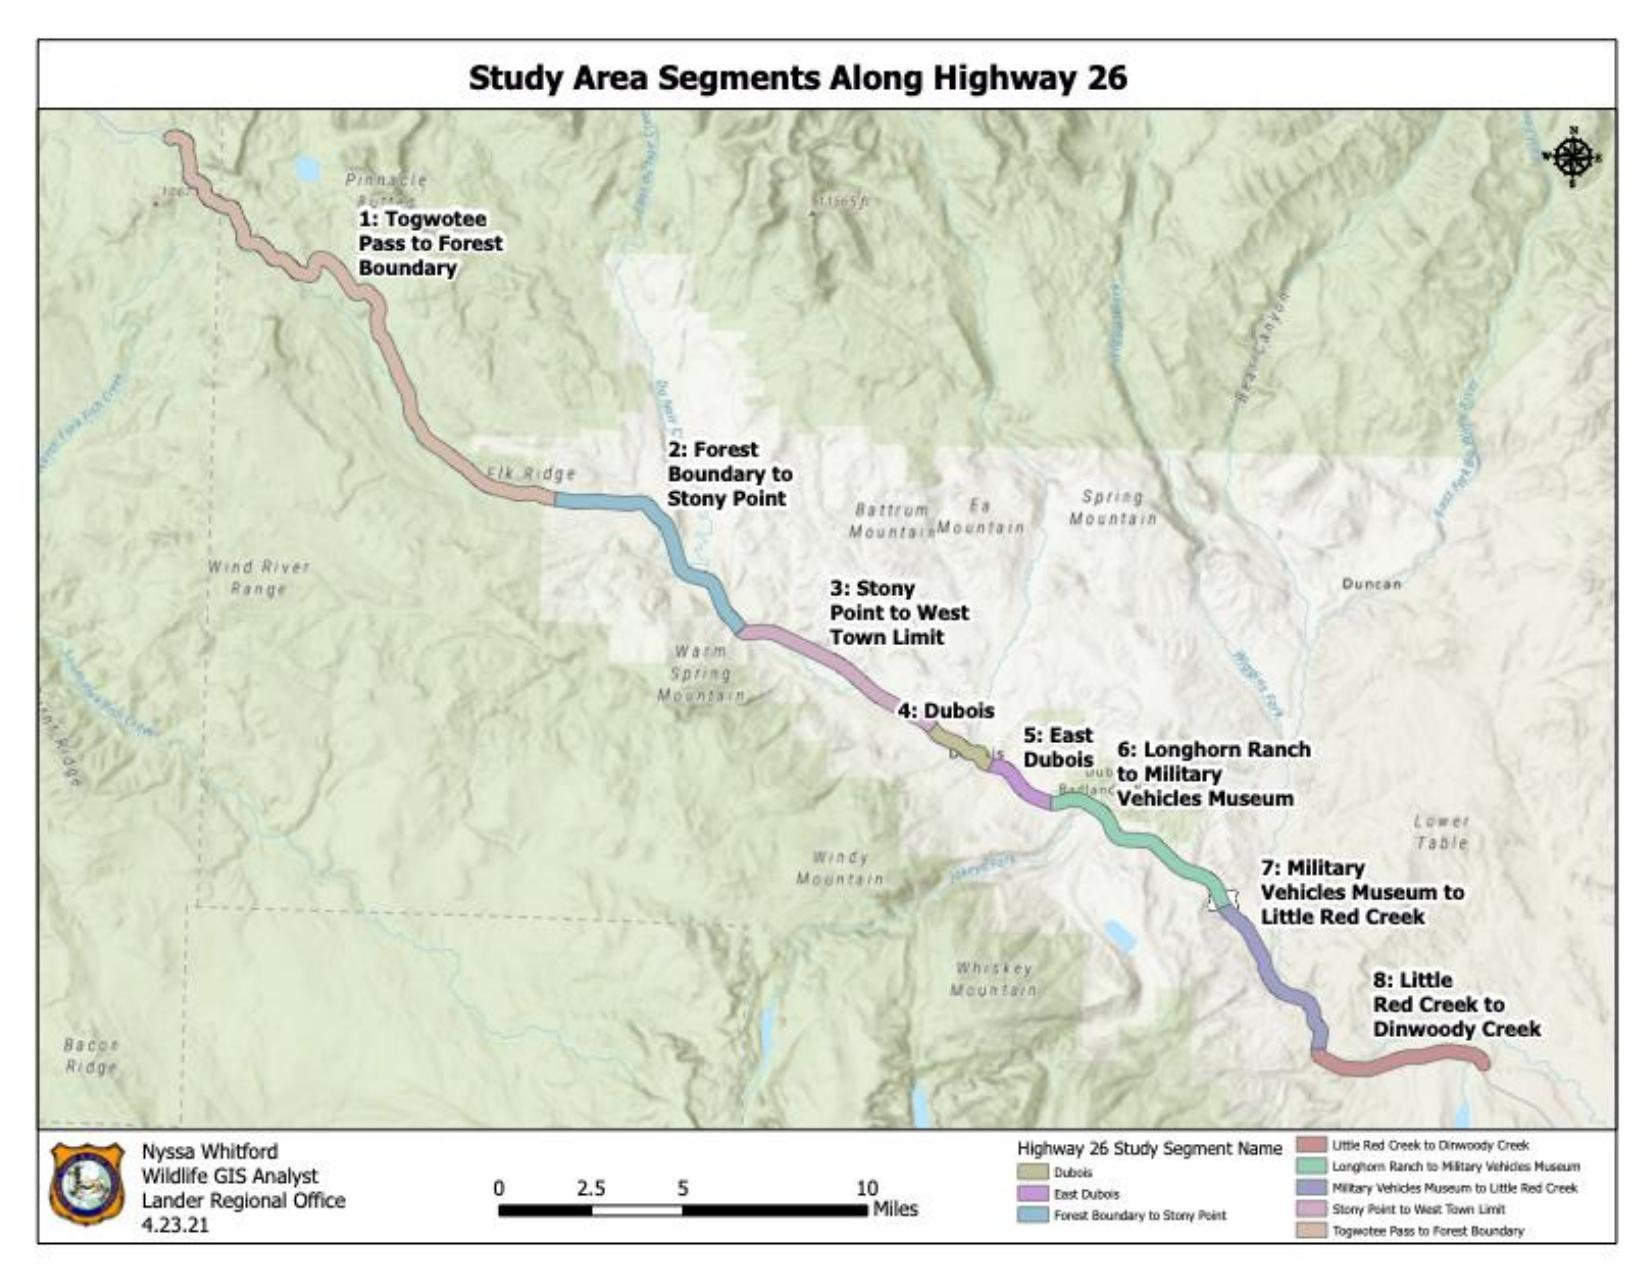
Figure 9. US 26 study area and mitigation segments.

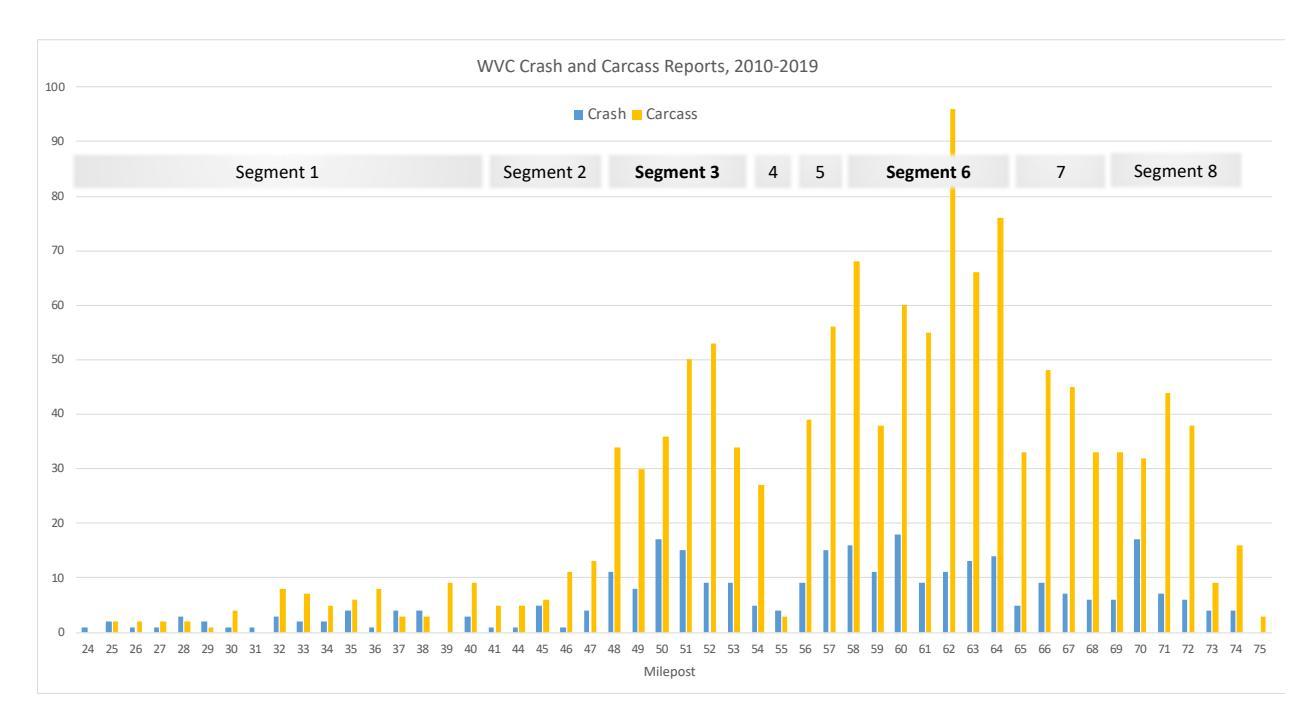
Figure 10. WVC crash and carcass reports per mile overlaid with the seven mitigation segments.

Mitigation recommendations were developed for each of the seven study area segments. Mitigation recommendations for each segment were based on wildlife movement patterns and needs, WVC rates (Fig. 10), land use, terrain, cost-effectiveness, and implementation feasibility, and were informed by the latest research on wildlife connectivity and WVC reduction strategies used in other locations. Several high priority segments were identified based on the need for mitigation in areas with high concentrations of wildlife and high WVCs.

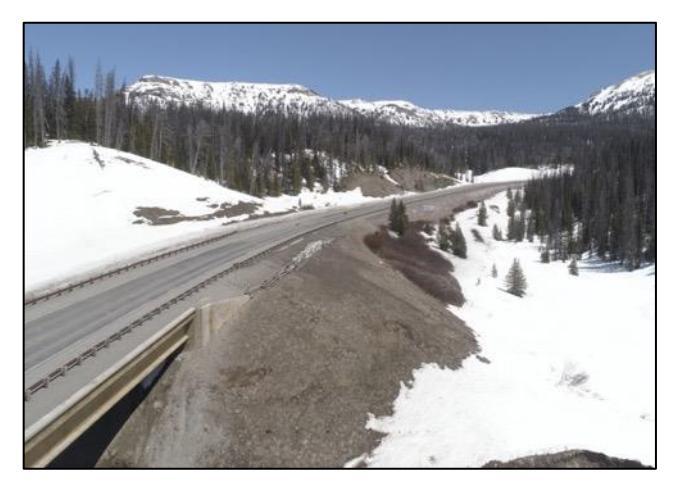
Figure 11. Bridge at MP 24.14 and associated buck and rail fencing, guard rail. Credit: J. Altschuld

Milepost	Location Description	Mitigation Recommendation	Priority
24.14	Buried bridge over	No additional guide fencing is currently recommended	Low
	tributary of	at this structure. To minimize conflict with animals that	
	Blackrock Creek	do attempt an at-grade road crossing, extend guard rail	
		on north side of the highway ~175' to the east (to align	
		with the retaining wall on the south side of US 26) and	
		west (to align with the end of the guard rail on the	
		south side of US 26 and the cut slope on the north side).

Guard rail does not prevent deer and other wildlife from
crossing a road but may help to discourage some at-
grade crossings. Aligning guard rail on both sides of the
highway may prevent animals (in particular, does with
fawns) from becoming partially trapped on the highway
and increasing exposure to potential WVCs.

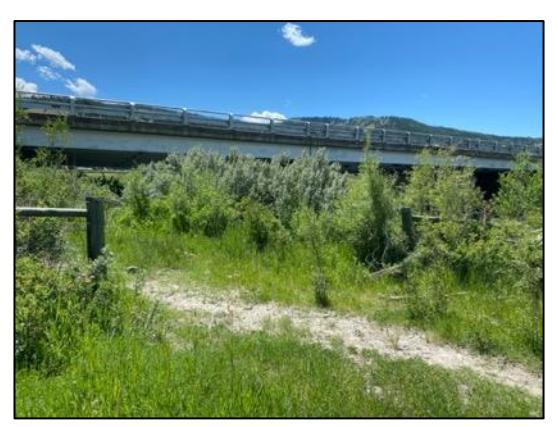
Figure 12. Game trail through gap in wildlife fence at the bridge over the Wind River at MP 46.43.

Existing bridges in this segment have high potential functionality for deer and other wildlife passage, although ROW and other fencing (e.g., horse corral) adjacent to these bridges restricts wildlife movements through several of the bridges. At MP 46.43, there are gaps in the ROW fencing along the riparian corridor and wildlife have created a trail through these gaps and under the bridge (Fig. 12). A large (10'W x 10'H) box culvert at MP 44.66 is located within BLM lands on either side of the structure. This culvert has high potential functionality for deer; elk are likely to use a structure of these dimensions in a more limited fashion, as solitary animals, pairs or small groups, and the structure may not provide passage for cows with calves.

45.66	Wind River bridge	Create wildlife pathways leading to and underneath the bridge on the east side of the river. WYDOT's 2021 ROW fence replacement project terminates on the west side of this bridge; the new fence on the west side of the bridge will be 5-strand barbed wire.	Medium

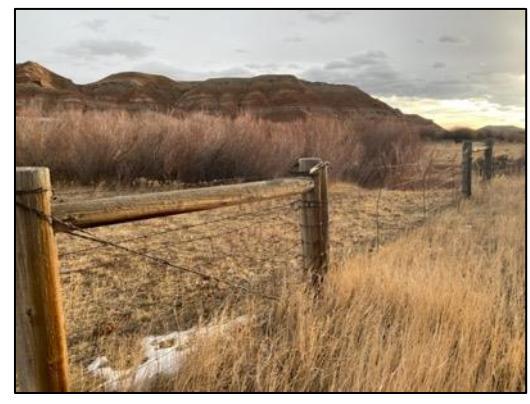
Figure 13. Example of woven wire fence and adjacent shrubby vegetation cover in Segment 3.

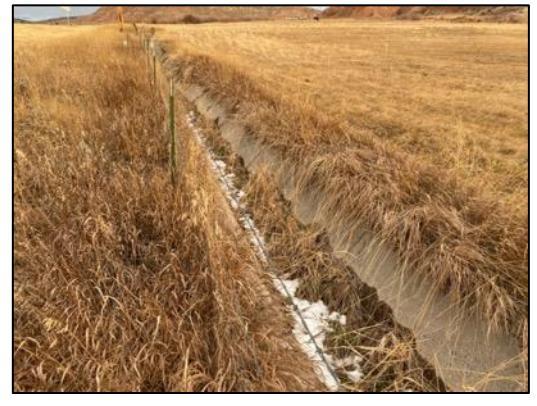
Figure 14. Concrete-lined irrigation ditch adjacent to the ROW fence, which, in conjunction, creates a substantial barrier for wildlife.

In addition to the ROW fencing, between MP 50-54, there is an irrigation ditch that runs parallel to the highway. Along much of its length, the ditch is concrete lined and several feet wide. In many places the ditch is immediately adjacent to the ROW fence, creating an even larger impediment to wildlife movements (Fig. 14). Shrubby vegetation adjacent to US 26 provides cover for wildlife approaching the highway, adding a surprise element, and reducing motorists' ability to detect approaching wildlife and slow down. Prominent visual obstructions in this segment were mapped by WGFD in fall 2020.

- Coordinate with landowners to identify targeted areas where the ROW fencing may be replaced with wildlife permeable fence types on both sides of the highway.
- Regarding the irrigation ditch between MP 50-54:
  - Coordinate with NRCS to determine whether inactive portions of the ditch may be removed or replaced with a pipe in berm. In some places the ditch does provide water for downstream uses.
- Identify opportunities to coordinate with landowners in areas where forage improvements could help keep wildlife on one side of the highway and lessen the need for them to move back and forth across the highway.
- Consider installing dual speed limit signs from October through May. This technology is currently being tested near Cody; if it is determined to be sufficiently reliable and can be shown to help decrease WVCs, then it may offer a complementary mitigation option for this segment.

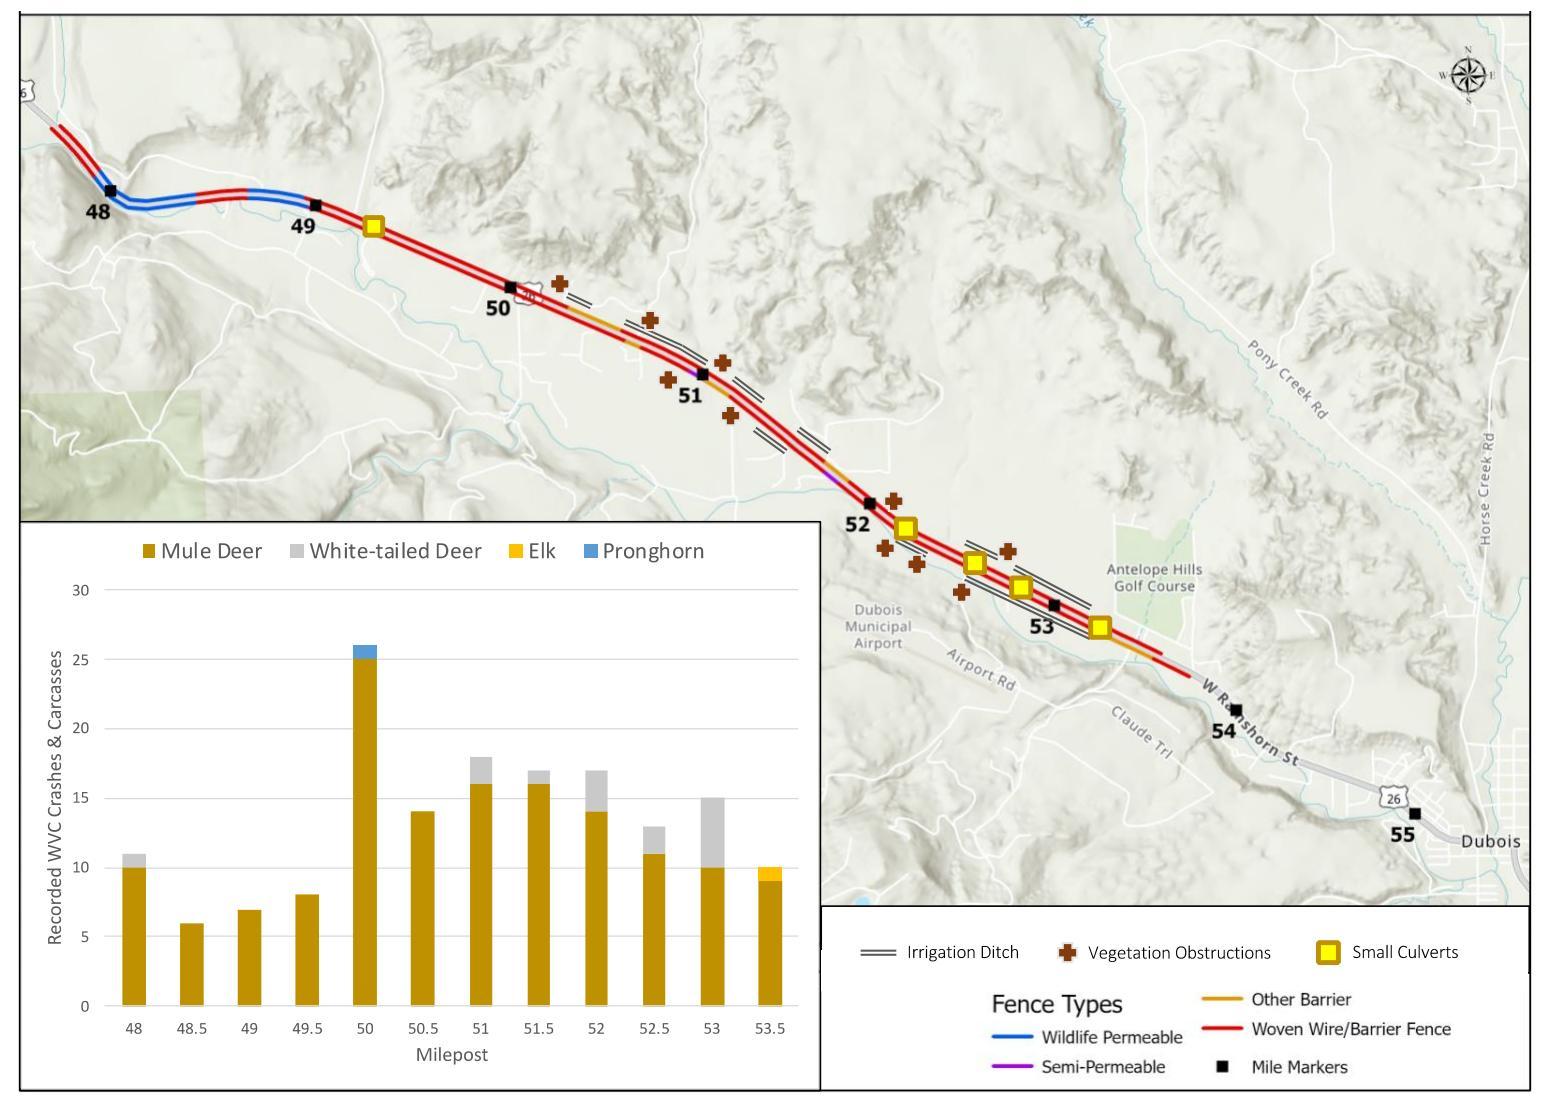
Figure 15. Existing conditions influencing wildlife movements across US 26 in Segment 3, West of Dubois (MP 48-54), including right-of -way fence types, small culverts (stock passes with some potential functionality for wildlife passage), sections of an irrigation ditch paralleling US 26, and roadside vegetation obstructions. Inset graph depicts wildlife-vehicle collisions by half-mile through the segment.

There are several medium-sized culverts (7-10') in this segment that offer potential functionality for wildlife passage. Most of these culverts are actively used stock passes, and in several cases, gates or fencing immediately in front of a culvert entrance prevents wildlife access to the culvert. In addition, domestic animal activity may limit the functionality of these stock passes for wildlife.

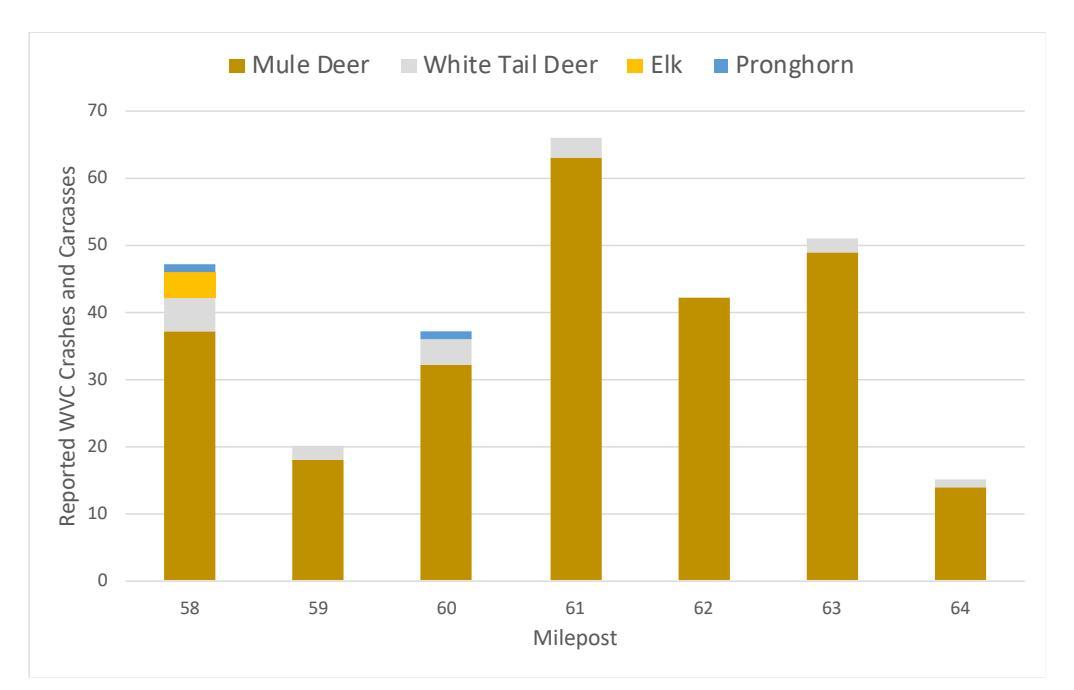
Figure 16. Reported WVC crashes and carcasses in Segment 6 from 2015-2019. MP 58 is at Longhorn Ranch/Kingfisher Road, east of Dubois; Red Hills Road is a MP 61.5, and MP 64 is adjacent to the Military Vehicles Museum. Note, only ½ mile of MP 64 is included in this segment.

This segment is comprised primarily of agricultural and pasture lands with some residential development, particularly around Red Hills. There are several large ranches with conservation easements between the South Fork of Torrey Creek and the Military Vehicles Museum (~MP 60.6-64) on the south side of the highway. With an annual average of 8.7 WVCs per mile per year, this segment has the second highest rate of WVCs in the study area, including the mile segment with the highest peak in WVCs at MP 61/61.5 (Fig. 16).

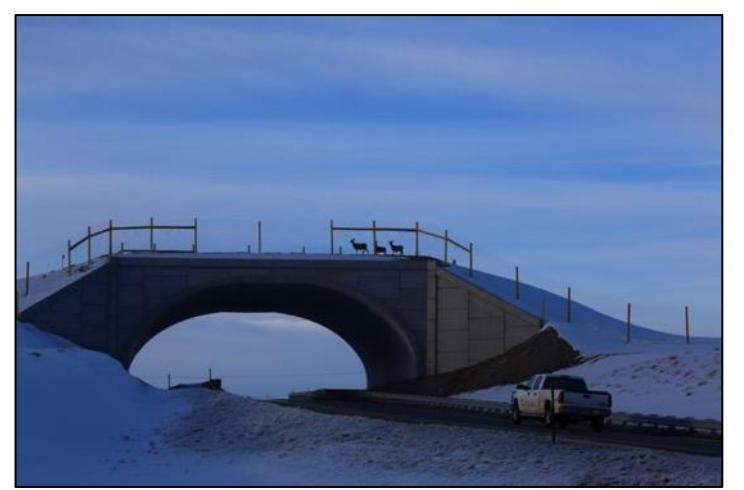
Figure 17. Example of a wildlife overpass on State Highway 9 in Colorado. This system of 2 wildlife crossing overpasses and 5 underpasses with wildlife fencing along 10.3 miles of highway was successful in reducing WVCs by over 90%. Credit: J. Richter

Potential locations for new wildlife crossing structures (Fig. 17) were evaluated based on several considerations, 1) building off the existing infrastructure and optimizing spacing such that wildlife have an opportunity to cross US 26 every 1-2 miles; 2) land use compatibility; and 3) terrain and construction feasibility. For this mitigation assessment, WYDOT conducted preliminary engineering reviews of four potential crossing structure locations. The proposed structure dimensions are preliminary and will be refined through future design processes. Alternative locations may also be feasible and should continue to be evaluated for the greatest benefit to wildlife and cost-effectiveness. The following table lists recommendations for enhancing wildlife passage at existing bridges and culverts as well as recommendations for new wildlife crossing structures (light gray rows). Eight-foot-high wildlife fencing connecting the existing and new structures would guide animals to these safe crossing locations and help to prevent WVCs on US 26 and would extend from the Wind River bridge near the east end of Dubois (MP 56.97) to east of the Military Vehicles Tank Museum (MP 64.1). The east fence end should be sited and designed to discourage wildlife from entering the fenced ROW and at a location with good visibility for motorists to prevent WVCs at the fence end. In Arizona, a wildlife crosswalk and driver warning system installed at a fence end was successful in meeting these objectives (Gagnon et al. 2018).

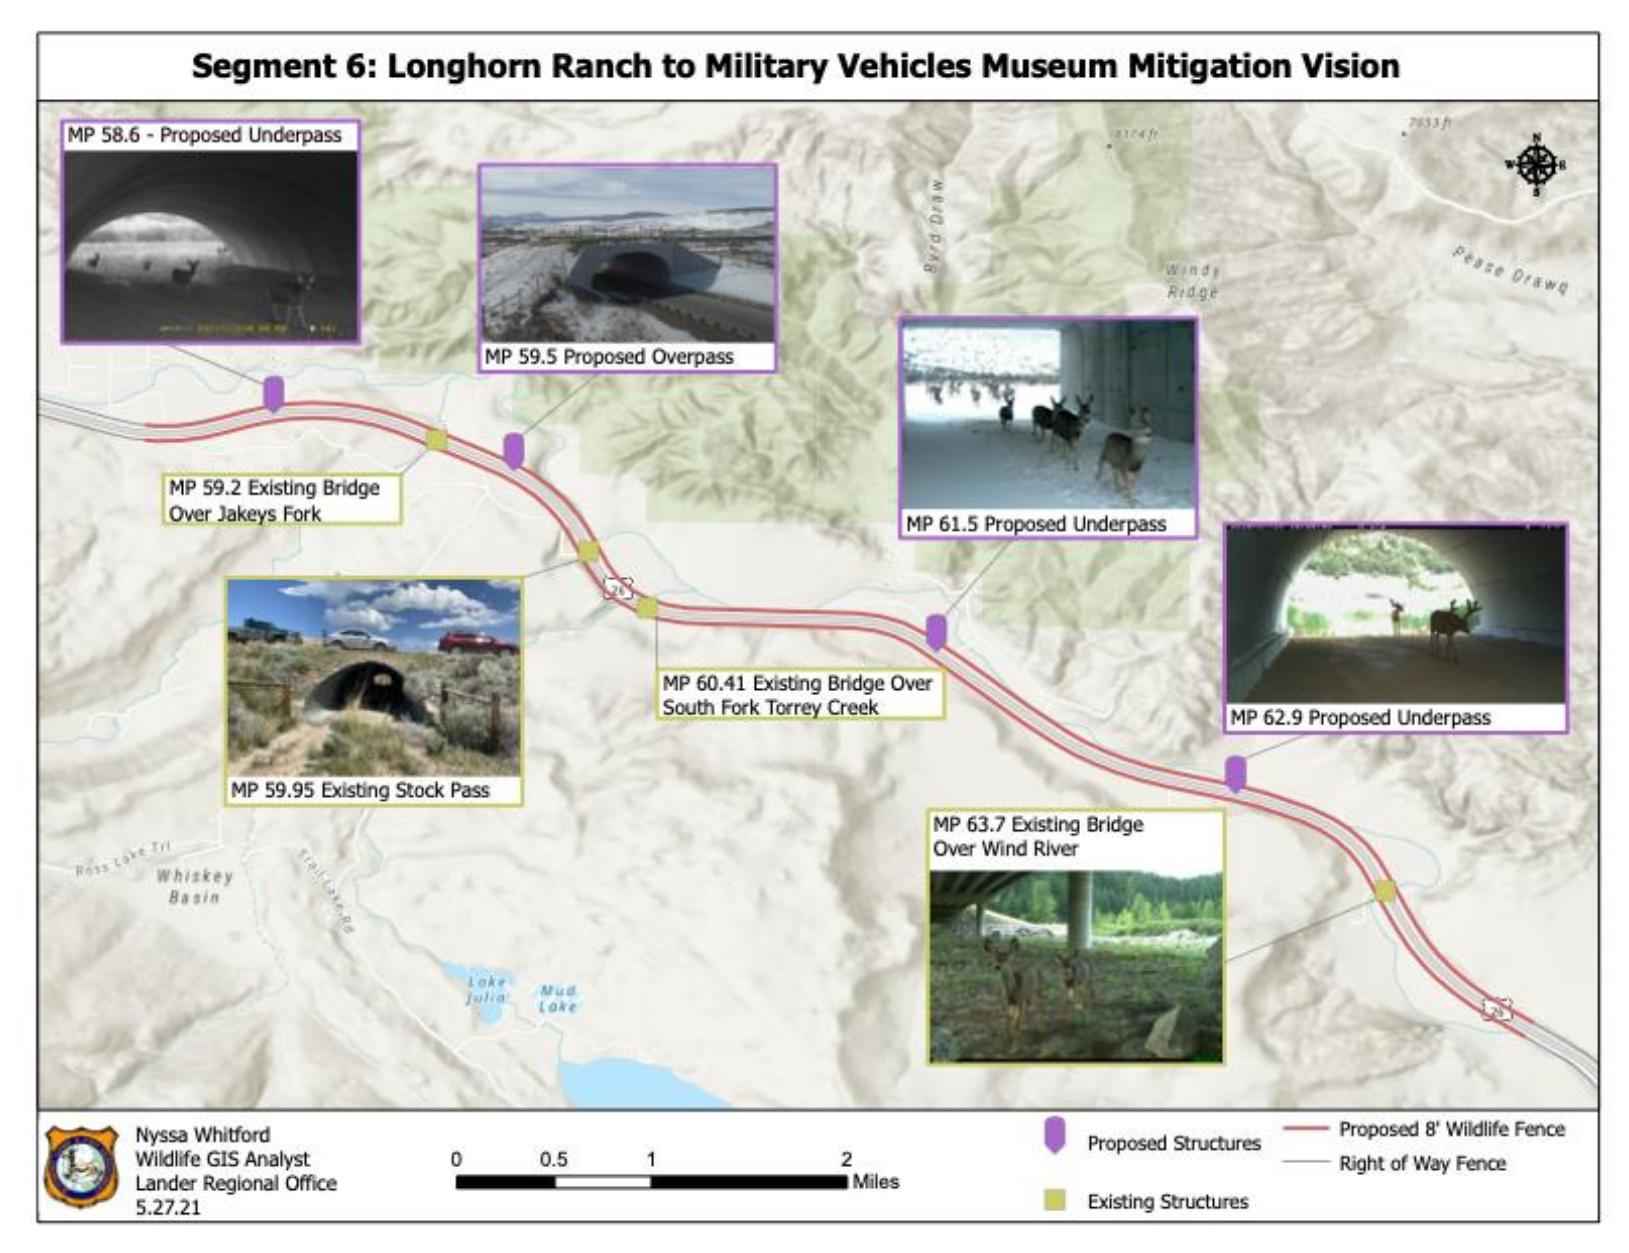
Figure 18. Mitigation concept for Segment 6, Longhorn Ranch to the Military Vehicles Museum (MP 58-64.5).

A schematic of the mitigation concept for this segment is presented in Figure 18. While the recommended mitigation strategies have benefits throughout the segment, due to funding availability, it is expected that mitigation construction may need to be phased. At this time, the recommended phasing is to construct the western portion of the segment first, from Longhorn Ranch to Torrey Creek (MP 58-61.5), as this section involves fewer landowners and greater construction feasibility based on the terrain adjacent to the highway. However, this phasing may be adjusted according to funding availability and other circumstances.

The cost of wildlife crossings mitigation in Segment 6, as described herein and depicted in Figure 18 is approximately \$6.7 million (Table 4). Based on these costs and cost savings, the costs of the mitigation would be realized within 27-29 years (Table 5). As the lifespan of a wildlife crossings is at least 75 years, these mitigation investments offer ongoing benefits far beyond the initial payoff period. This is a highend estimate that does not include increases in the cost of crashes and the value of wildlife over time or discounted costs over the life of the crossing structures. In addition, this benefit-cost analysis does not include other unquantifiable benefits or passive values such as wildlife population health or the ecosystem values of connectivity.

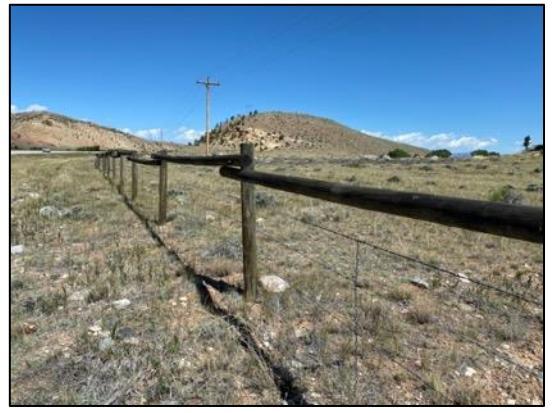
Figure 19. Wildlife permeable elk-post fence in Segment 7.

There are few existing bridges or culverts in this segment. However, a long span bridge across the Wind River at MP 66.91 offers high potential functionality for wildlife passage. The ROW fence around this area is an elk-post/top-rail variety with a smooth bottom wire 16" above the ground level and a wood rail across the top that makes the top of the fence much more visible for wildlife jumping over the fence and reduces the likelihood of leg entanglement (Fig. 19).
